Updated: February 4, 2009

Product: DL3

Subject: SDI cable routing

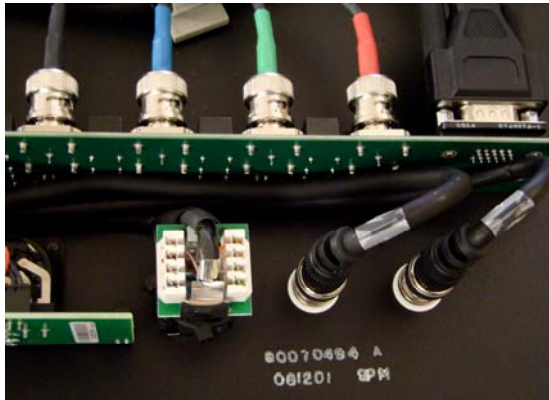
In some instances the SDI cable can be damaged due to its routing underneath the Video I/O PCB. If the cable is moved while in this position, the cable insulation can be punctured by the components soldered though the board. It is unlikely that this will cause the SDI cable to fail, but it is recommended that the cable be re-routed.

Original routing
underneath PCB

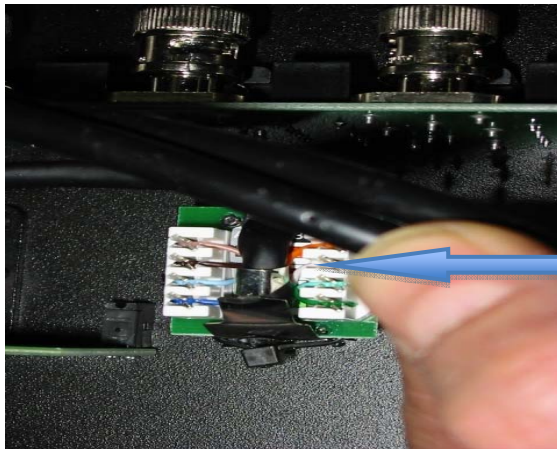
Possible damage
cause by PCB
