<h1>Technical Bulletin</h1>	Flying Pig Systems	Page 1/2
	<b>Hog iPC Video Card Riser Reengagement</b>	23-Nov-09	Rev A

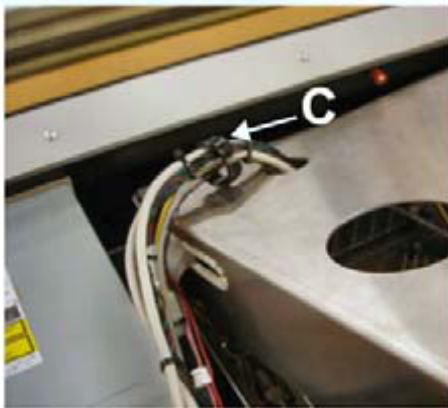
NOTE: Some older Hog iPC consoles have the wiring exiting through the top of the computer housing through a snap-in strain relief (C).

Gently lift the cover and snap the strain relief up and out of the mounting hole, and then feed the wiring through the keyhole slot.

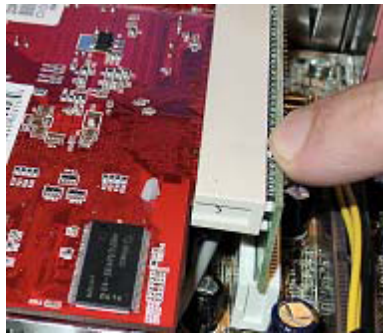
The video card riser board used within the Hog iPC console may become slightly dislodged after rough shipping. When this occurs, users will experience loss of the second and third video outputs. High End Systems recommends this simple procedure to reengage the video card connection. If problems with the video card riser connection continue, then contact HES support at 800-890-8989 or [support@flyingpig.com](mailto:support@flyingpig.com).

4. Gently lift up the computer housing cover so the motherboard is exposed. Locate the video card and riser on the motherboard.

Push down with slight pressure on the end of the video card riser board nearest the console wrist rest until the card reengages into the slot. (Take care to only press on the green board so as to not bend the video card socket.)
