Flying Pig Systems

Wholehog II Expansion Wing Hardware design errors - fixes

Two hardware errors have been found in the design of the Expansion Wing.

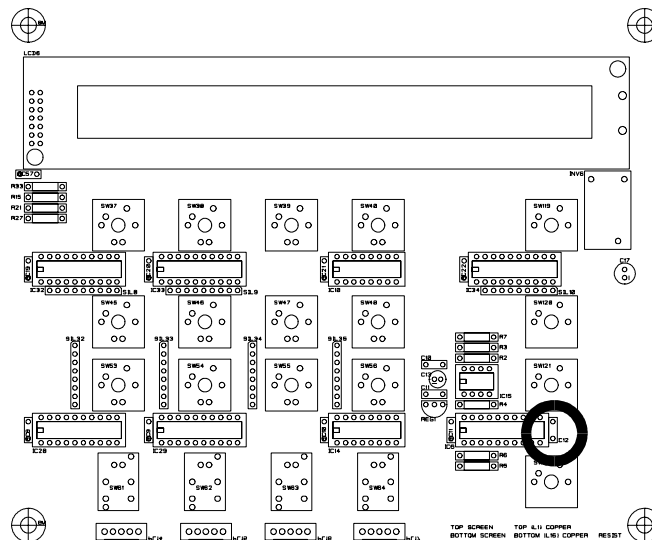
Error #2:

Serial numbers affected by error #2: 0228 - 0260

The faders may not zero correctly or may twitter about zero in hot conditions. This will cause the Flash LEDs to flash or flicker if intensity information present in the assigned Cuelist. The Event Monitor can be used to confirm this condition, you will notice a frequent Wing fader events.

Capacitor C12 should be removed from the PCB by a qualified technician. This modification can be performed **WITHOUT** removing the PCB from the metalwork – consult the diagram below for the whereabouts of this capacitor in the bottom righthand corner of the board.
